Important Bavaria 37 & 41 autopilot drive check-up.

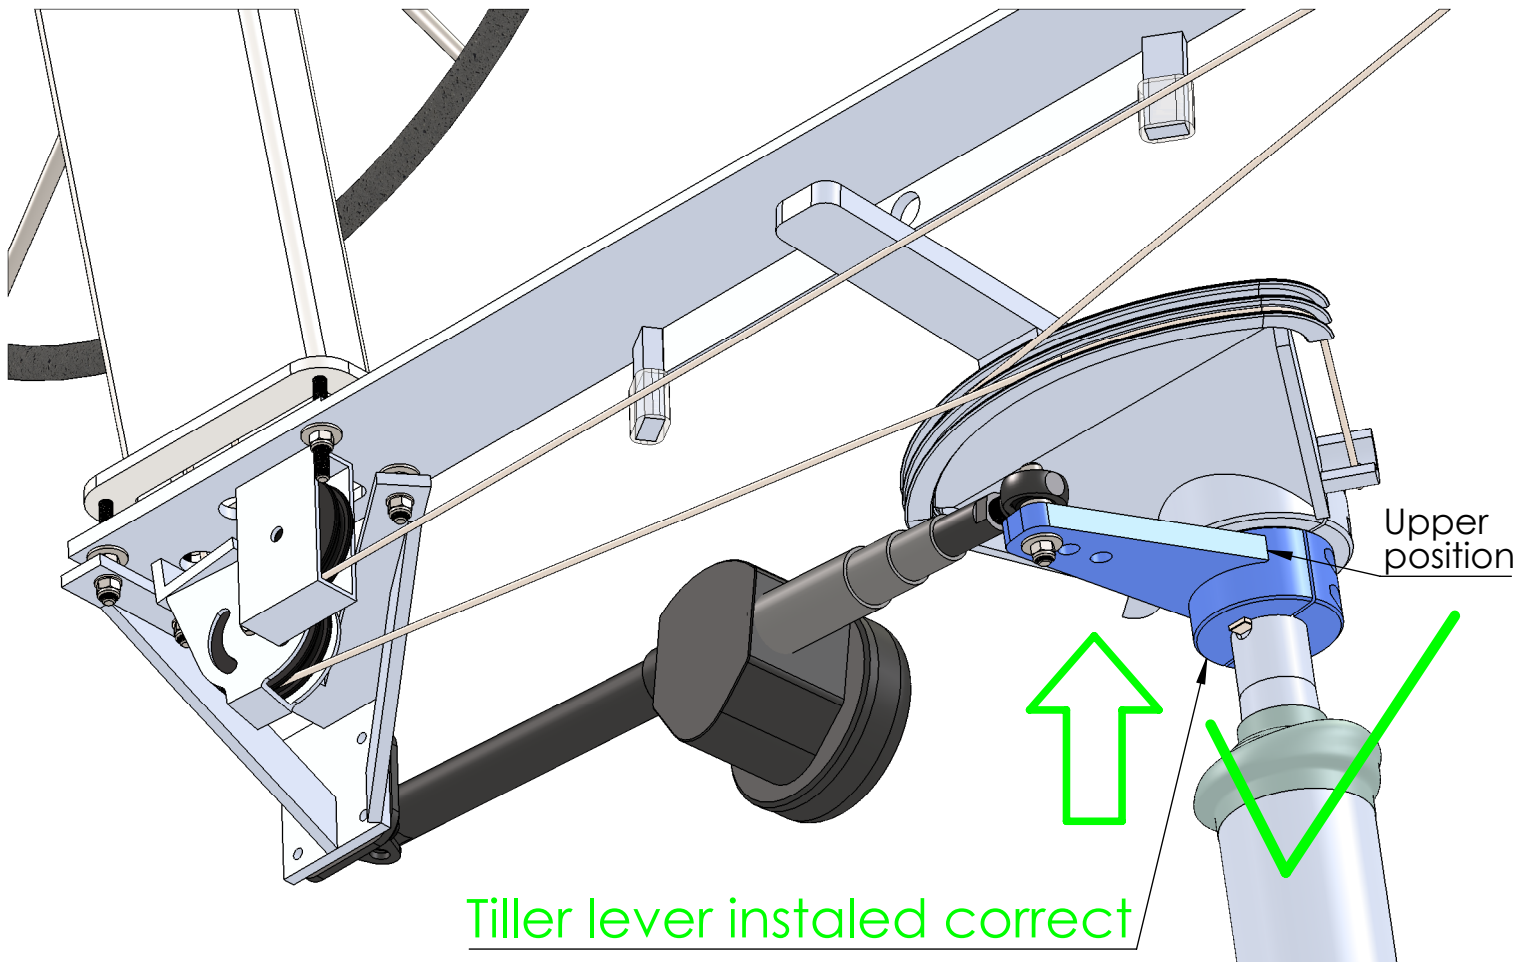
Tiller lever on Bavaria 37 and Bavaria 41 should always be mounted in such way that the arm always is in the upper position. The picture above shows the correct installation of the tiller lever. The picture below shows the wrong installation of the tiller lever.
